D1013 Bogie Overhaul Update, by Graham Gant

The following is a brief update on D1013's Bogie Overhaul, as at December 2024. Please note that most of the photos have been taken by the WLA's Working Members as the project progressed.

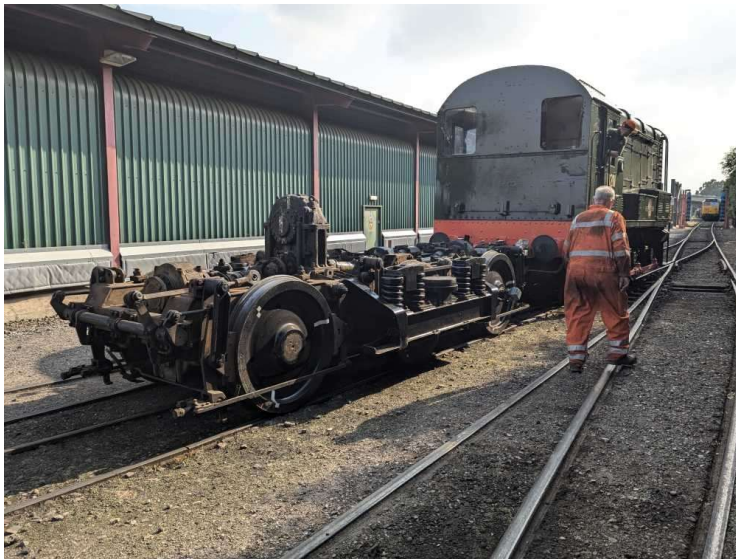
On Friday, 20th September 2024, D1013's B end bogie was relocated from the TMD Pit Road to No.3 road in the TMD, accomplished by using the 08 to drag/push the bogie (pic 1)

Picture 1 – Bogie Shunt

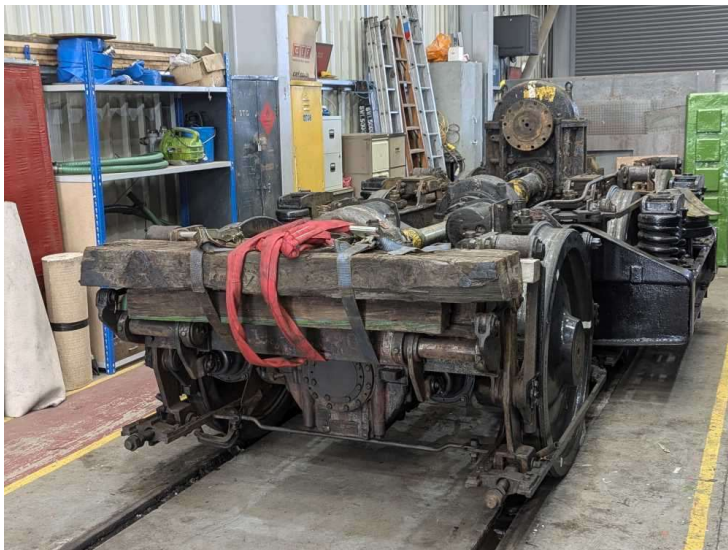
There was a bit of a lash up of wooden sleepers to aid this (pic 2)

Picture 2 – Bogie Shunt showing wooden sleepers used

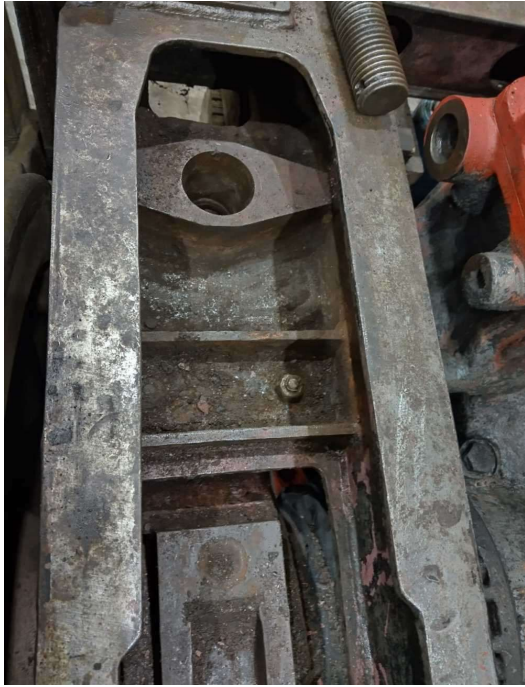
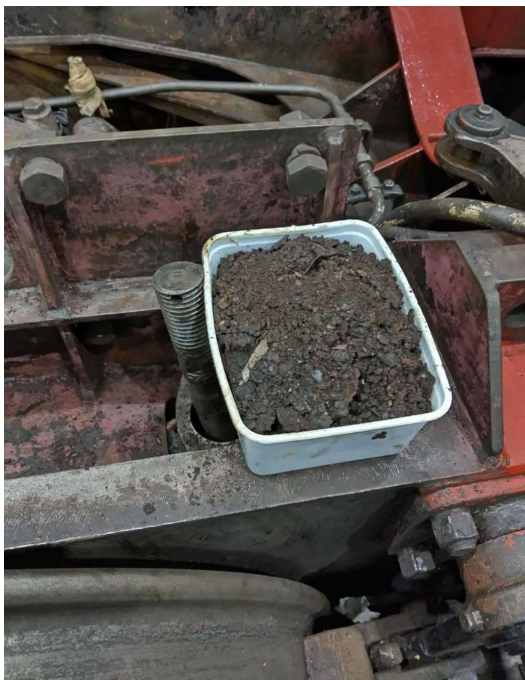
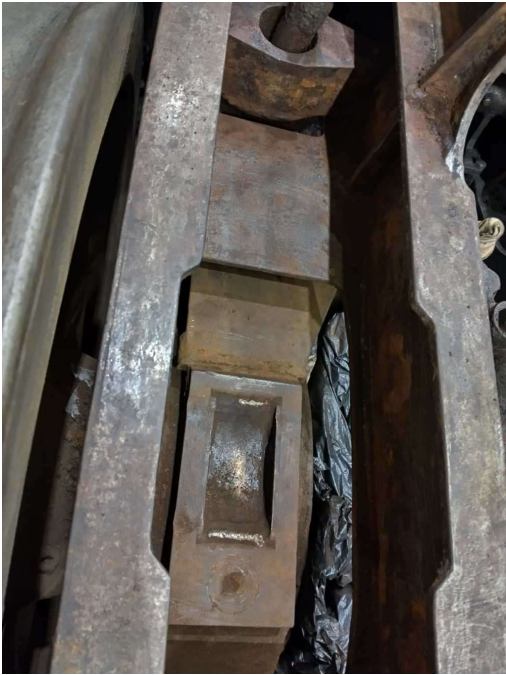
Once D1013 had arrived on No.3 Road there has literally been hundreds of man hours spent removing 50+ years of 'baked' on brake dust and railroad dirt, at this point I would like to say a very big thank you to all the volunteers who have done any scraping. The frames are being 'scraped' back to bare metal revealing original paintwork, the bare areas are then being coated with red oxide primer, this will eventually be coated with Chassis Black. (pics 3 - 8)

Picture 3 – Bogie Scraping

Picture 4 – Bogie Scraping

Picture 5 – Bogie Scraping

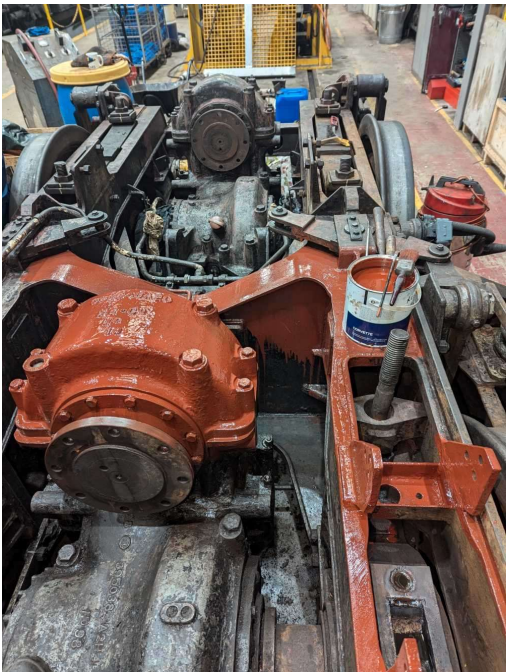
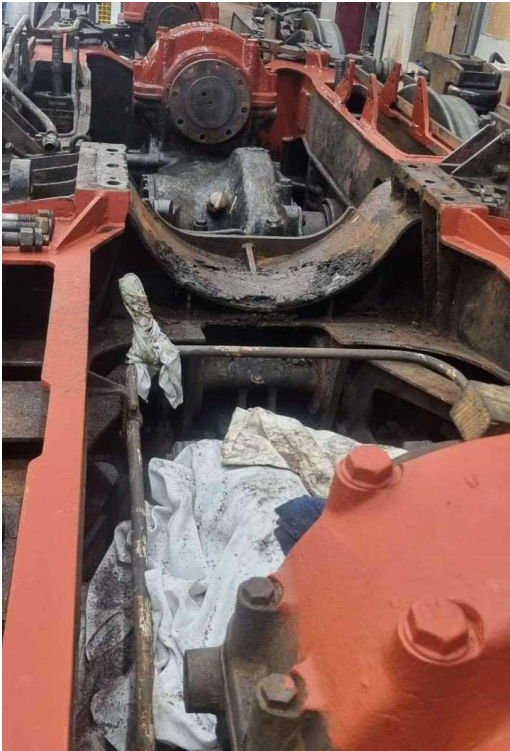
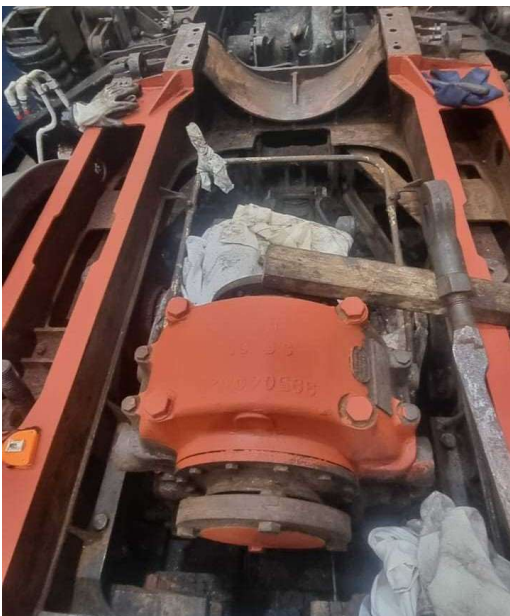
Picture 6 – Painting

Picture 7 – Painting

Picture 8 – Painting

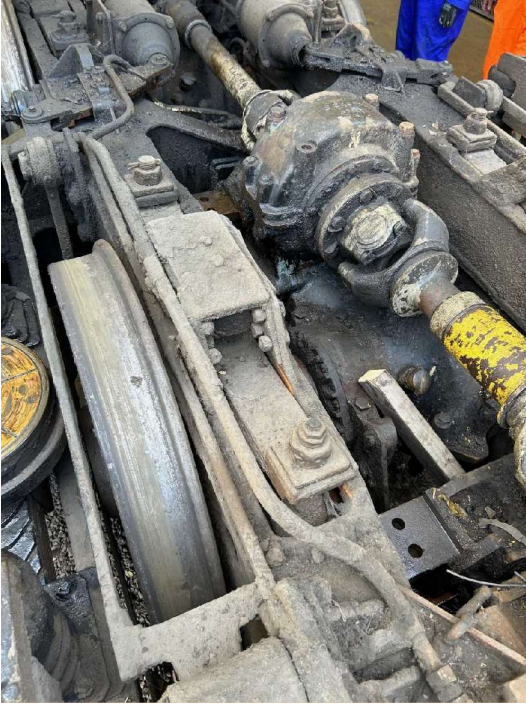
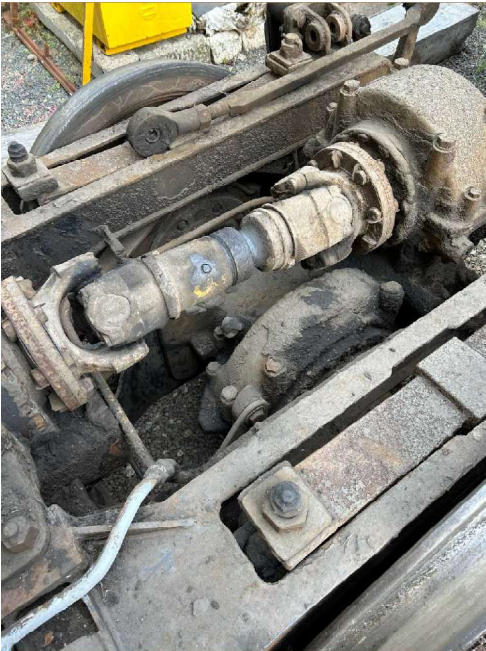
The WLA Team have also started to remove component parts; the first items removed were the Drive Shafts, a little 'gentle' persuasion was required, once they were out of the way, the Thrust Brackets were lifted from the Bogie - these brackets are basically used to push the loco along. (pics 9 - 12)

Picture 9 – Drive Shaft

Picture 10 – Drive Shaft

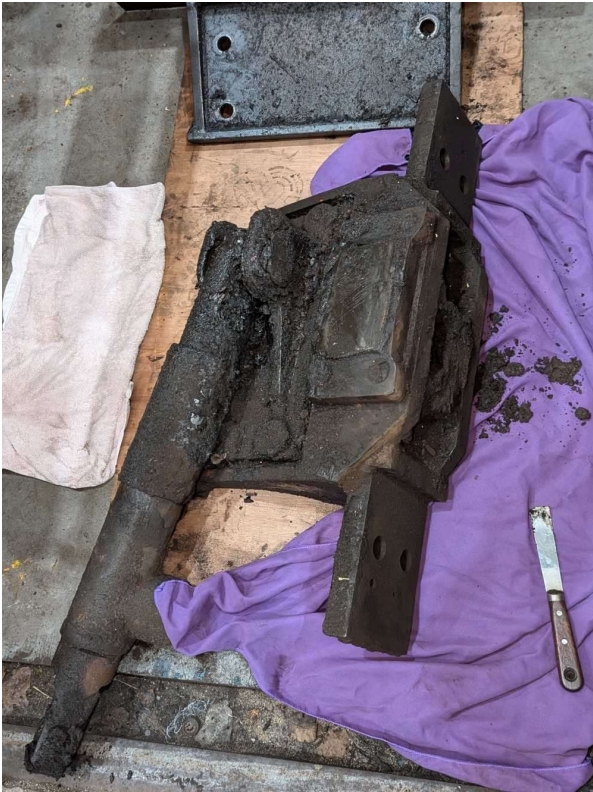
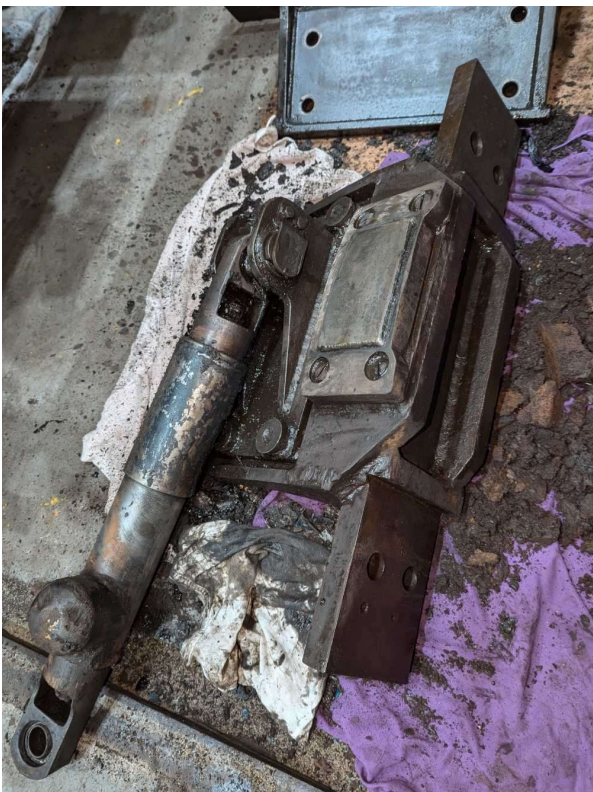
Picture 11 – Thrust Bracket

Picture 12 – Thrust Bracket

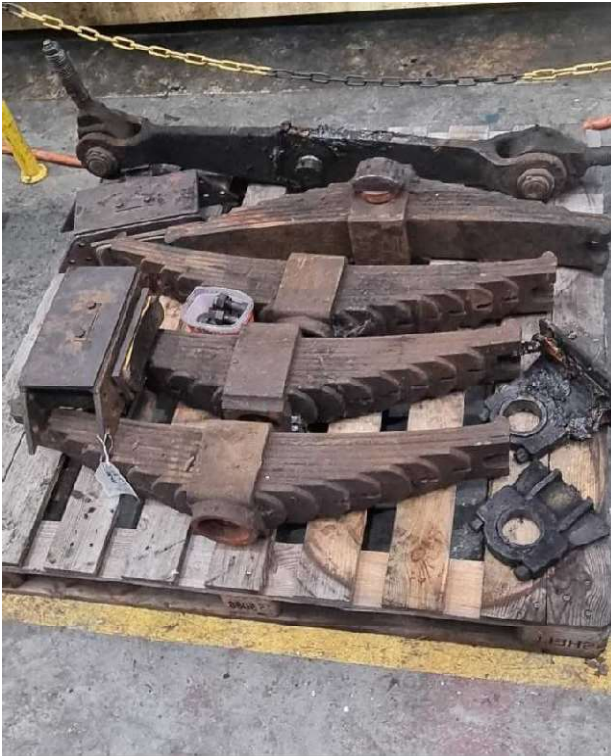
Following our in-house procedure, the next items for removal were the Equalising Beams but before attacking these items, measurements were taken for the Primary Spring heights. The 4 Primary Springs were released and then lifted clear of the Bogie. The Primary Springs sit on top of the Axlebox and there is a Locator between the Spring and the Axlebox; this Locator has a Manganese Liner welded to it - it was common for the weld on these to fail and we have evidence of this (pics 13 -16).

Picture 13 – Primary Springs etc

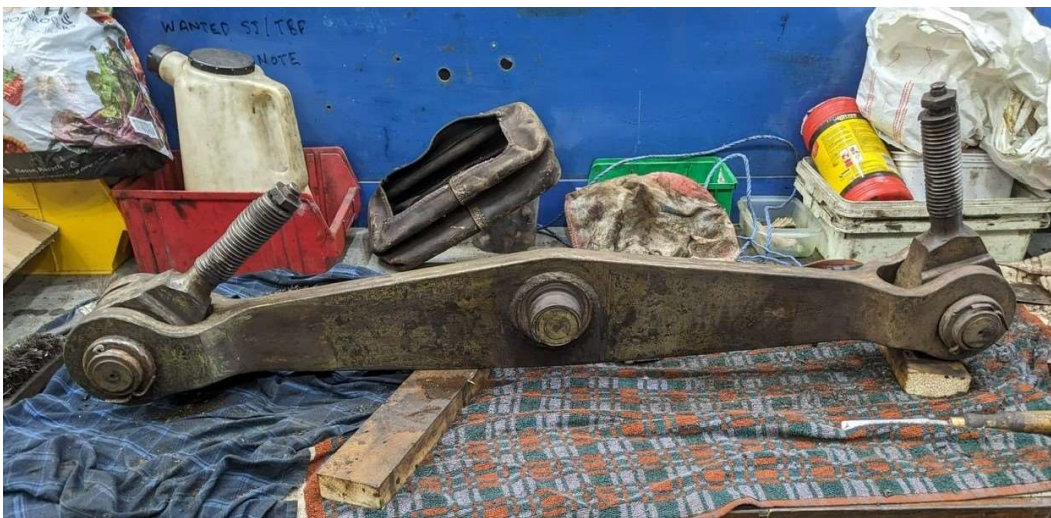
Picture 14 – Equalising Beam

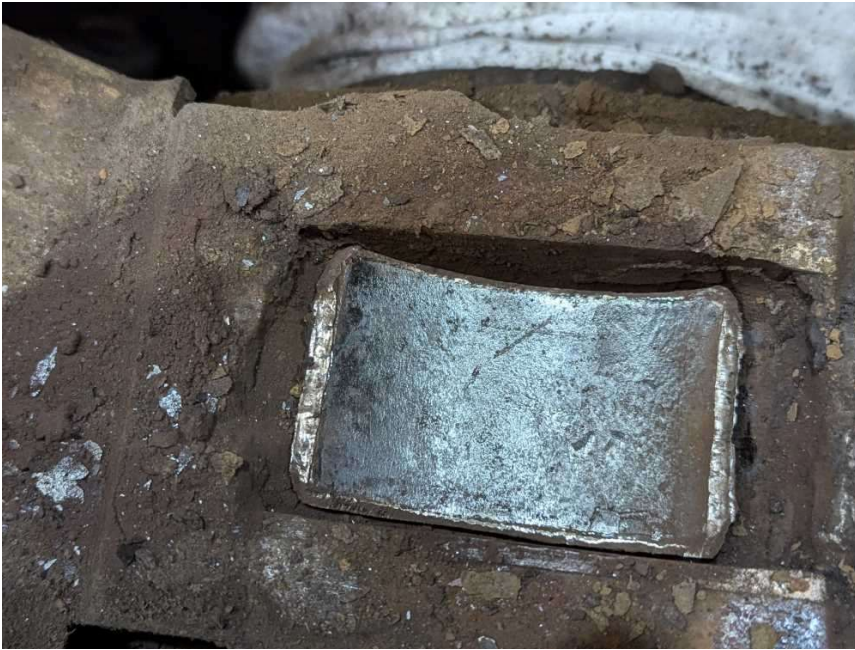
Picture 15 – Spring Locator Liner

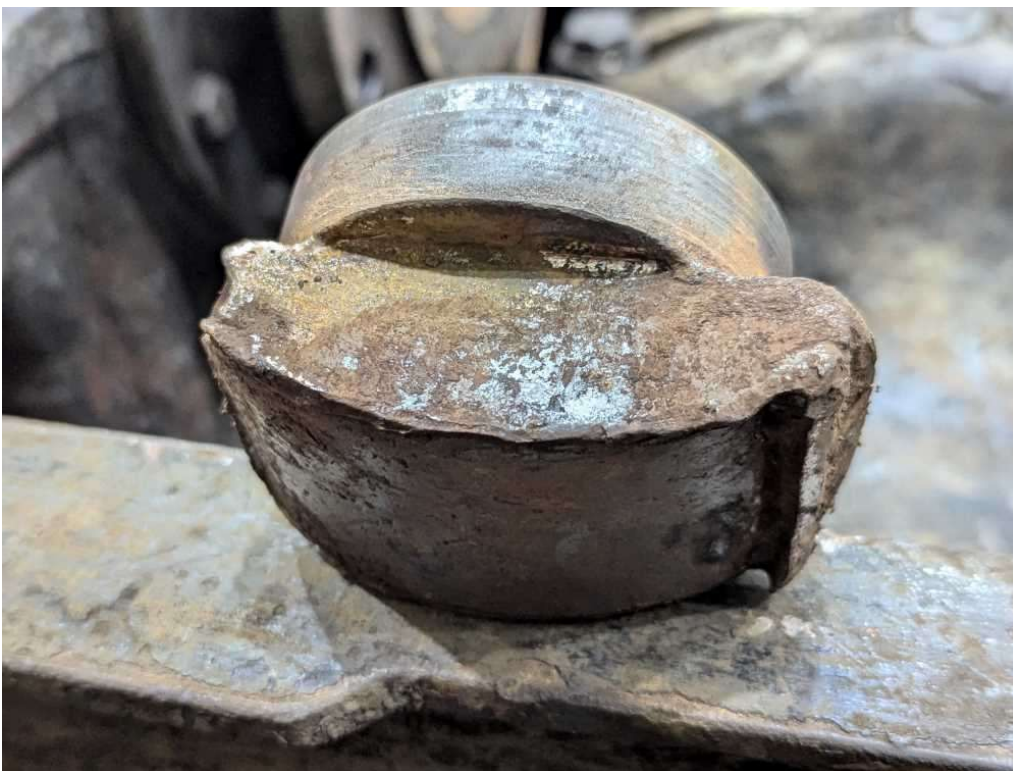
Picture 16 – Spring Locator

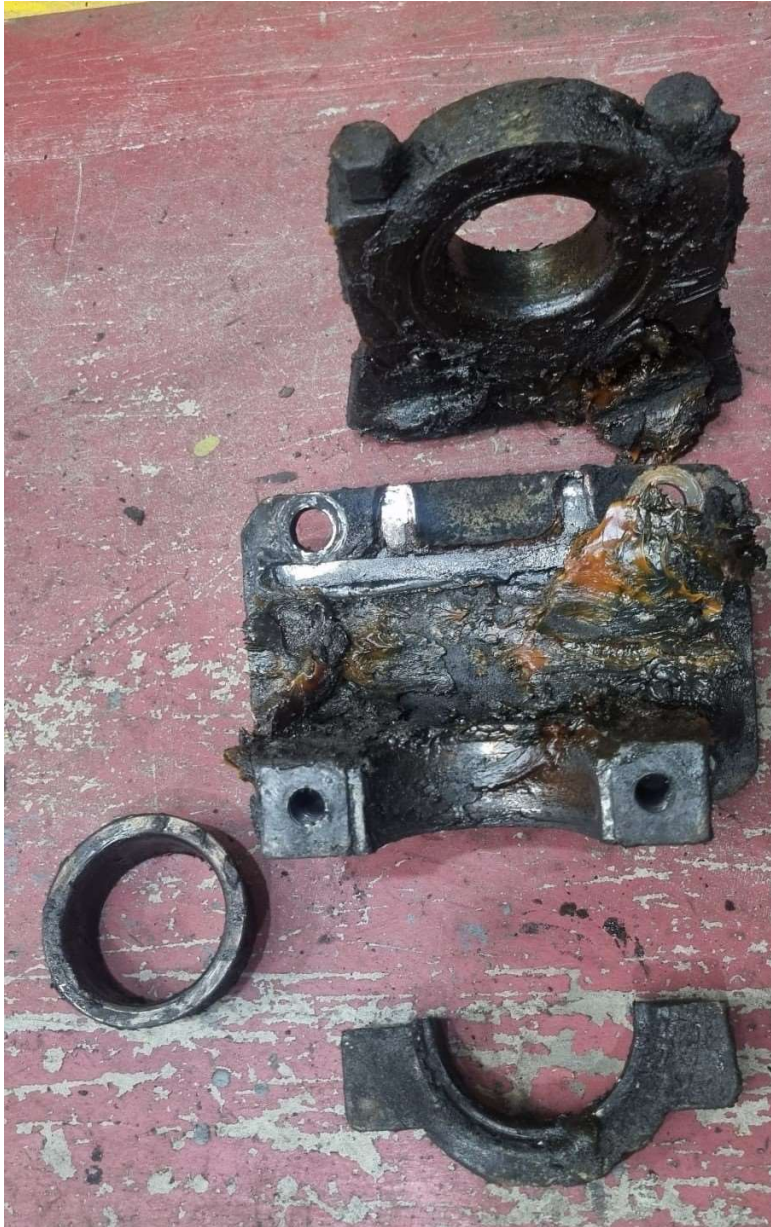
The first Equalising Beam proved quite 'easy' to remove as one of the Pedestal Brackets that supports the Beam in position had 'fallen' apart, a lack of weld penetration during the construction of the Bracket being the cause. (pic 17)

Picture 17 – Pedestal Bracket

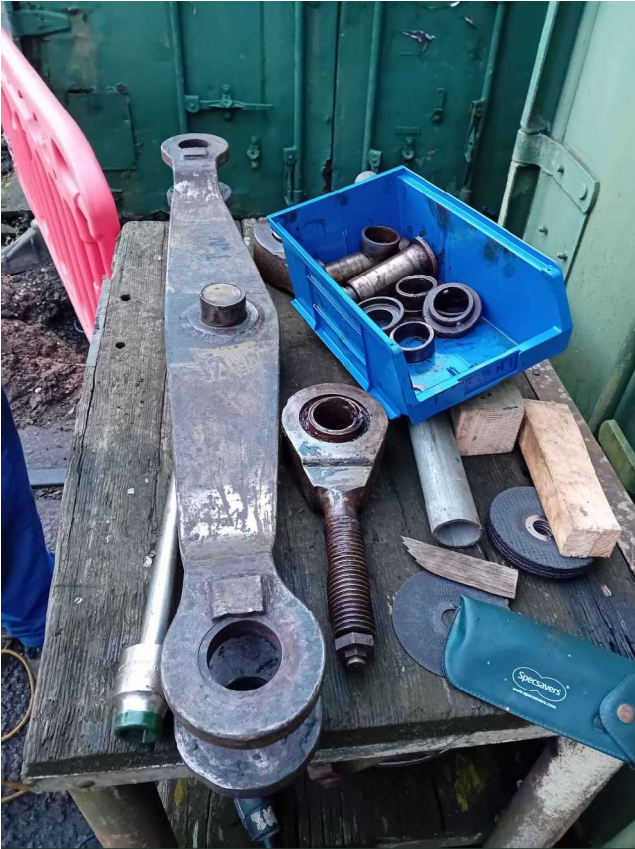
The 2 Equalising Beams have subsequently been taken to our Bridgnorth workshop for assessment and dismantling (pics 18 - 19)

Picture 18 – Equalising Spring Stripped

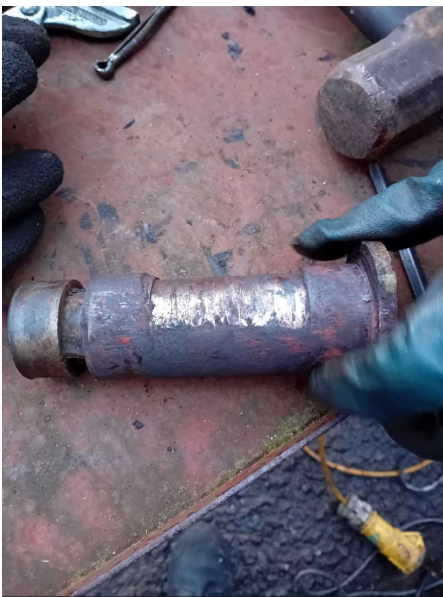
Picture 19 – Equalising Beam Worn

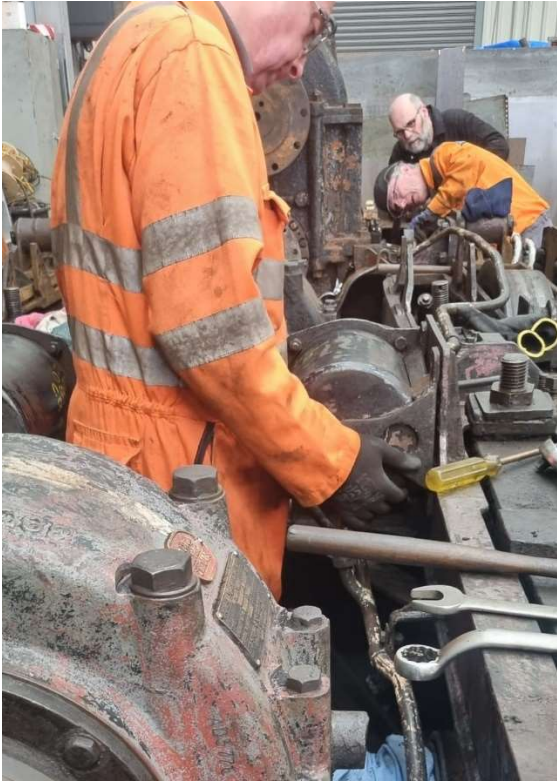
The 2 Brake Cylinders serving the Centre axle were also removed (pic 20)

Picture 20 – Brake Cylinder Removal

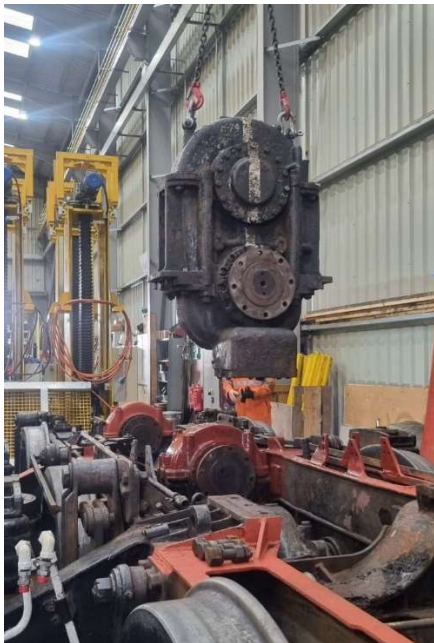
Attention then moved to unbolting and lifting out the Intermediate Gearbox (pic 21)

Picture 21 – Intermediate Gearbox Removal

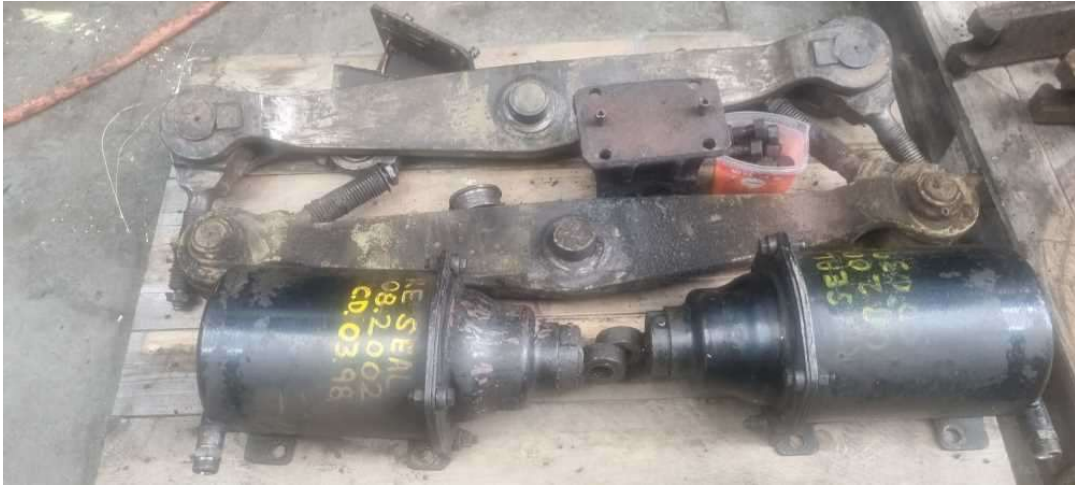
The 2 Brake Cylinders serving the Inner axle were the next items to be removed (pic 22), also at the same time the last 2 Primary Springs were released and lifted clear of the Bogie.

Picture 22 – Brake Cylinders & Equalising Beams

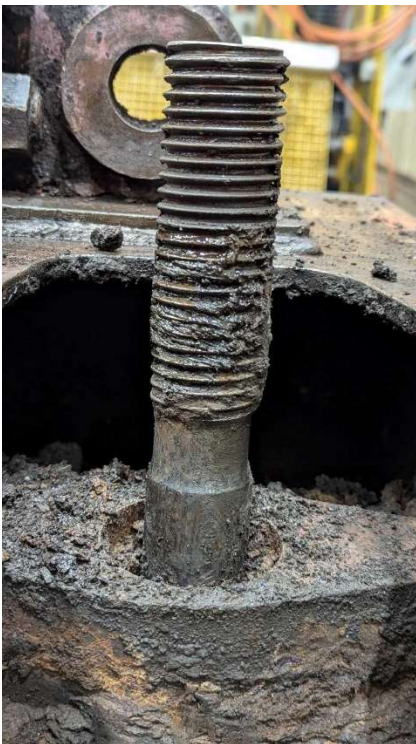
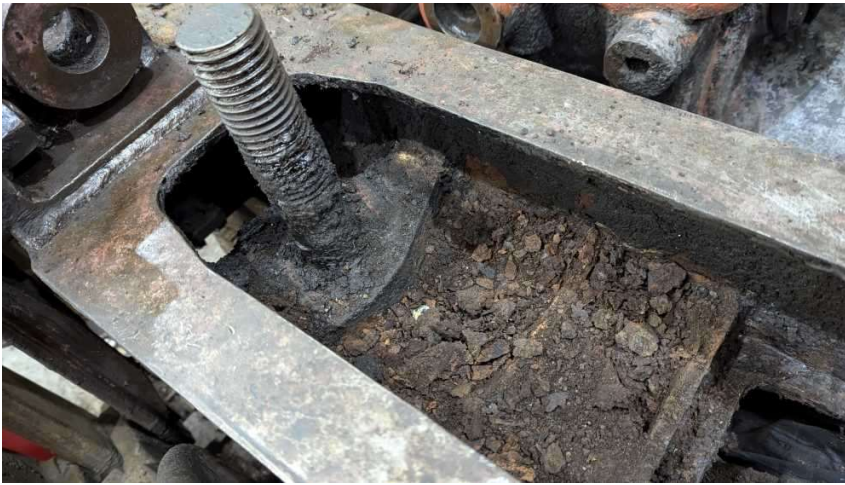
Removing the Primary Springs has exposed the Spring Hangers, one of which has virtually 'welded' itself in place, after much soaking in oil and more 'gentle' persuasion this Spring Hanger has now been removed (pic 23 -25)

Picture 23 – Spring Hanger Stuck Solid

Picture 24 – Spring Hanger Stuck Solid

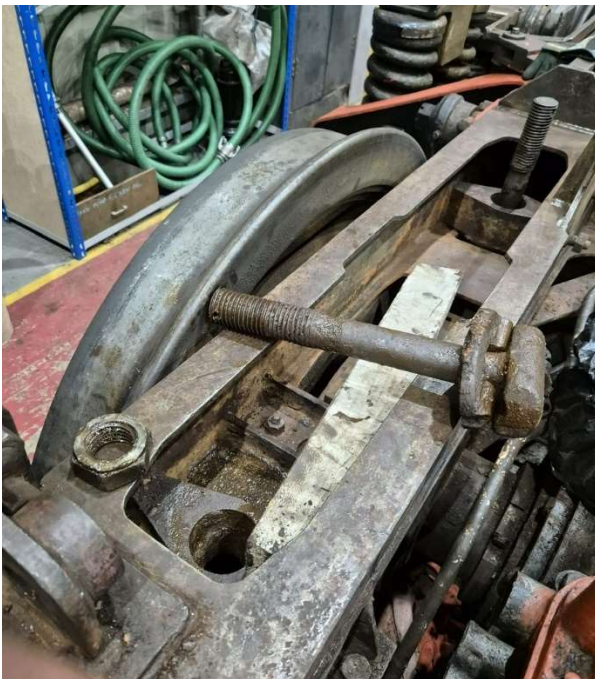
Picture 25 – Spring Hanger Out!
